Solar Photovoltaic Plants: Construction and Maintenance Issues

By Panos Antoniadis, Technical Inspection Engineer, RINA Tech UK LTD
Panos.Antoniadis@rina.org

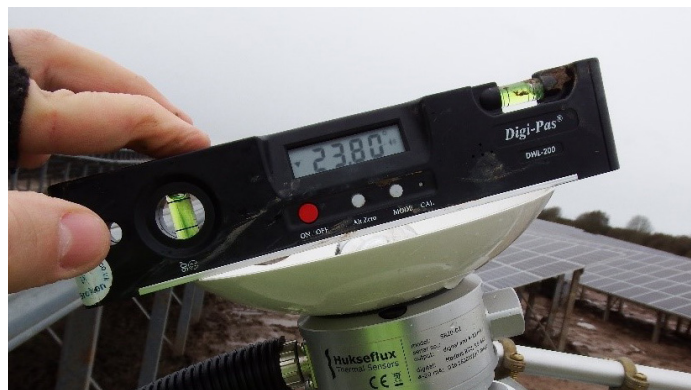
Pyranometers measure the irradiance at a solar farm, and their data is crucial to measuring the performance of a project and enforcing its performance warranties. I have witnessed hundreds of pyranometers which have been neglected. Some had not been calibrated in years, while others had their domes covered in algae or soiling. These are delicate devices that require monthly maintenance checks and should typically be calibrated every two years to maintain their accuracy. Another common issue is the inclination of the pyranometers - hundreds of them had been installed out of their contractual inclination. Owners and contractors should be careful not to overlook these important devices as Performance Ratio (PR) calculations may be compromised due to inaccurate pyranometer measurements.

Figure 2: Pyranometer out of inclination

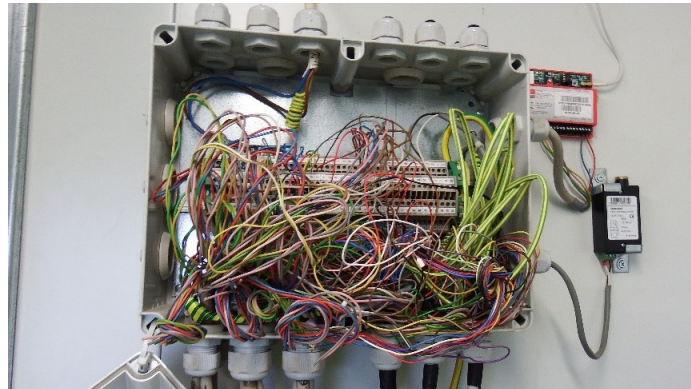
A very common issue is the amount of inadequately terminated and non-isolated communication cables in cabinets. Unlabelled and excessively long communication cables, all tangled together and squeezed in a small cabinet box make it impossible for an engineer to diagnose and resolve a communications issue. All cabling should be adequately labelled, and equipment should be installed in cabinets large enough to accommodate them.

Figure 3: Inadequately terminated and non-isolated communication cables in a cabinet

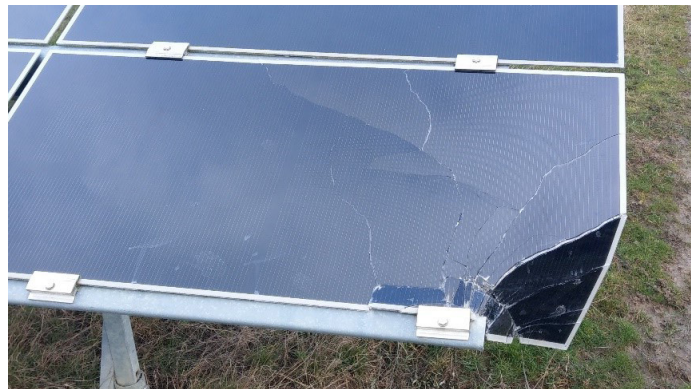
I often identify damaged modules when visiting sites. This module damage can be caused by mounting structure damage, from poor handling during construction, or lax maintenance practises. Module damage can be challenging to diagnose purely from monitoring a project’s control system remotely, so issues can affect solar farms for longer than would be preferable. Often module damage can be identified through visual inspection, however some damage cannot be identified visually. I often perform DC string and I-V curve testing or thermography for clients to identify damage to modules or other parts of a solar farm, and would recommend string, I-V curve testing and aerial thermography is performed annually.

Figure 4: Damaged module

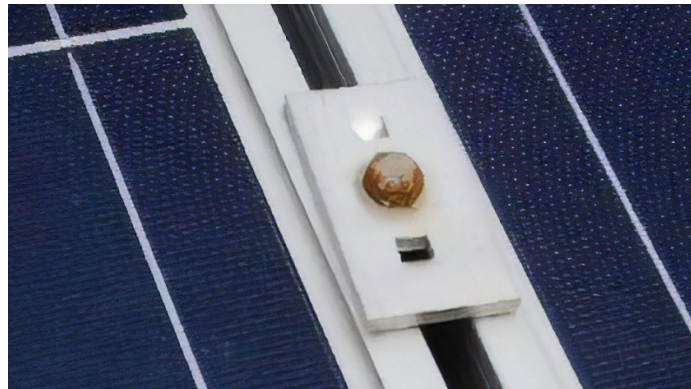
The structure is predominately made from galvanized steel and can last for more than 20 years. But often I see rust build-up and corrosion on these structures, particularly in PV plants close to the sea. On other occasions, the same problem appears in fixings (bolts and nuts) - these usually arise because of bad practices during installation (i.e. the usage of powerful power tools might strip away the protective layer of zinc and expose the bare steel to oxygen and moisture.). Farming equipment such as tractors can also damage lower sections of the structure and solar modules while grass cutting. Unfortunately, these problems are rarely identified by O&M teams or asset managers, leaving the damaged sections vulnerable to rust and corrosion.

Figure 5: Module clamp corrosion on fixing

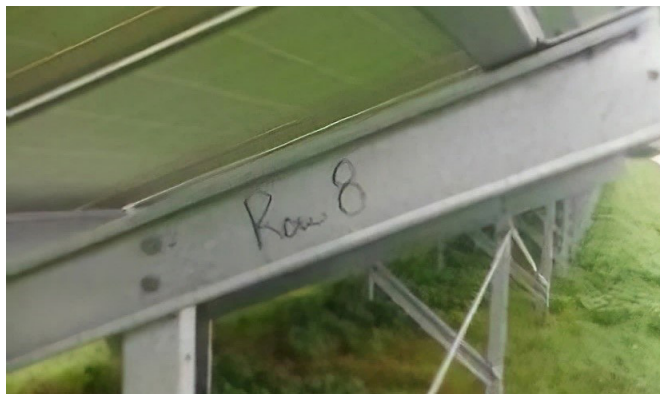
- Lack of health and safety signage, either on access gates or perimeter fencing, to ensure risks to the public and staff are effectively communicated
- Poor labelling of components and equipment across site, making it challenging to identifying a location on site or finding the culprit causing an issue

Figure 6: Inadequate identification of mounting structure row

It is a legal requirement that signage should be selected and installed in accordance with the Electricity Safety, Quality and Continuity Regulations 2002 and relevant Health and Safety site assessment to all fencing and buildings of a plant generating energy, and we recommend this issue is not overlooked when finalising the construction of projects.

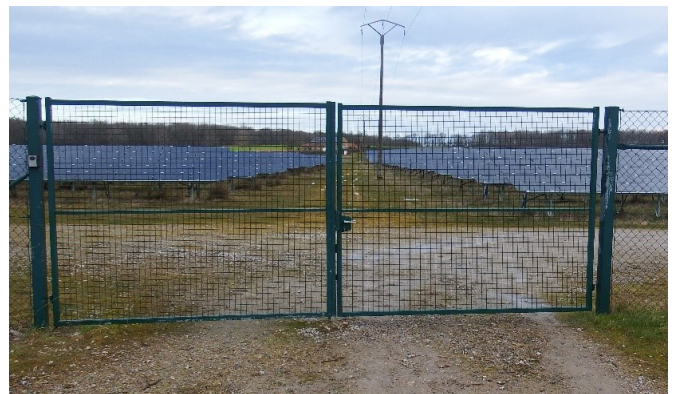
Figure 7: Missing identification on PV plant access gate

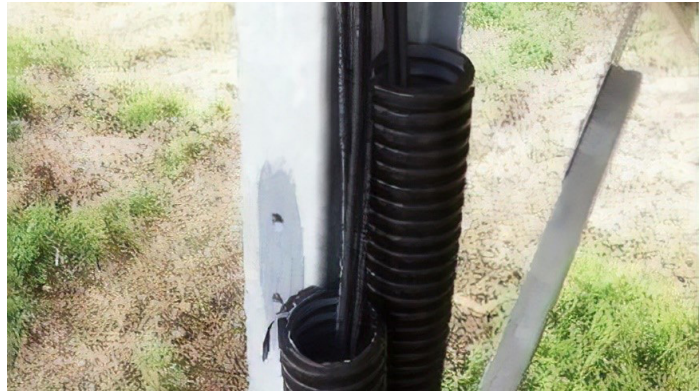
A PV plant can have kilometres of cables running underground and through the mounting structure. These carry the energy produced on site, and it is imperative that their integrity is maintained to the highest standards, to ensure that there is no downtime or health and safety risk to staff. Regulations in the UK state that cables that run underground should be enclosed in ducting to protect the cables from external mechanical forces. Ducting can be avoided if armoured cables are used. As the cost of armour cabling is high, contractors choose instead cabling with double insulation, as this is largely acceptable in Europe. As technical advisors, we highly recommend that contractors follow the regulations and guidelines of the country that the PV plant is build, and make the appropriate selections when it comes to cabling. One more typical issue we observe on a PV plant is unsealed cabling ducting above ground. Exposed ducting can allow easy access to vermin underground and usually vermin such as rats can damage cabling and cause extensive problems to a site. An adequate material for the environment should always be used to seal all exposed ducting across the site. It is recommended that the chosen material is cement based and it should take into consideration the impact of fire, UV radiation, wildlife and atmospheric conditions and be designed to last the lifetime of the project.

Figure 8: Unsealed cable ducting

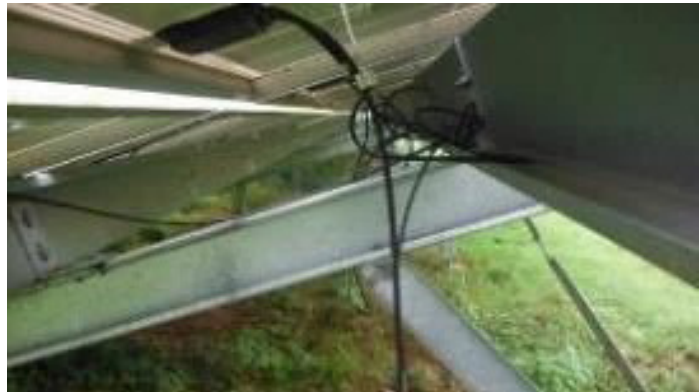
Inadequate cable management includes missing cable protection against livestock, cabling between tables exposed to external influences such as wind, ice formation, temperature and solar radiation or not mechanically supported and protected.

Another common issue is having cables exposed to sharp edges, under compression or not adhering to minimum bend radius.

Figure 9: Inadequate cable management

Low quality cable management can lead to small amounts of current leaking via the cabling (Riso faults). Cable insulation can be damaged if cables are mishandled during construction or it might perish if left exposed to direct sunlight and other external conditions.

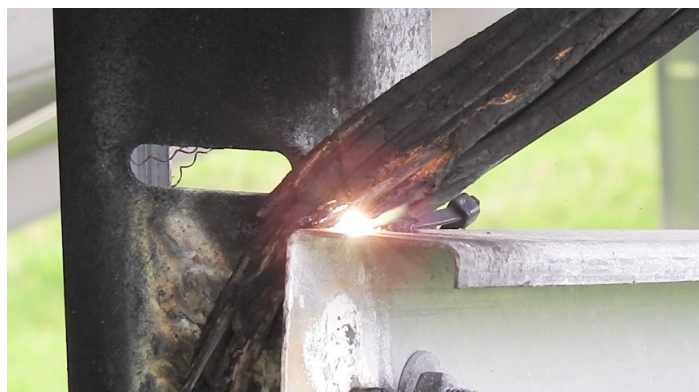
Riso faults might cause inverters to trip, communication issues, or worst, electrical arcing and subsequently, fires.

Figure 10: DC string cables on fire

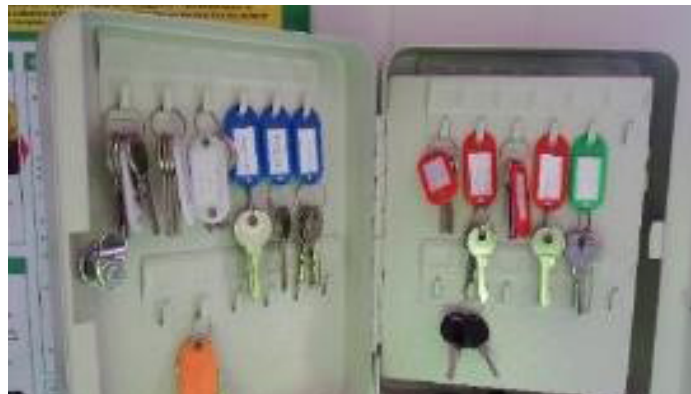
It is very common for PV plant access keys to be inadequately stored. In particular, regulations in the UK state that keys which allow access to high voltage rooms and stations should be kept stored in a safe manner, segregated from any other keys. In numerous occasions, low voltage (LV) and high voltage (HV) access keys have been found stored in the same key safe.

Any untrained and unauthorised person working on the site could easily access these rooms, potentially endangering themselves and causing problems to the plant.

Figure 11: LV and HC access keys stored in the same key safe

It is recommended that HV keys should be segregated from LV keys and safely stored in accordance with the applicable Health and Safety site assessment and site risk assessment. Access to HV keys should only be accessible by HV accredited personnel.

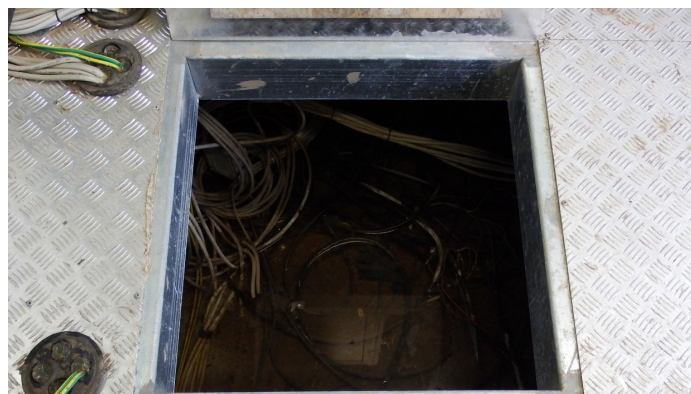
Substations are mainly built on concrete foundation pits, which allow easy cable entry from underneath. However, cable entries are rarely sealed, allowing water to enter the pits and accumulate in the foundations of the substation.

Figure 12: Water in substation foundations

This can potentially compromise the lifetime of the components - such as switchgears - inside the cabin, and/or invalidate their warranties. If such issues are identified it is recommended that water is pumped out and cable entries adequately sealed in order to ensure water tightness and prevent high levels of humidity.

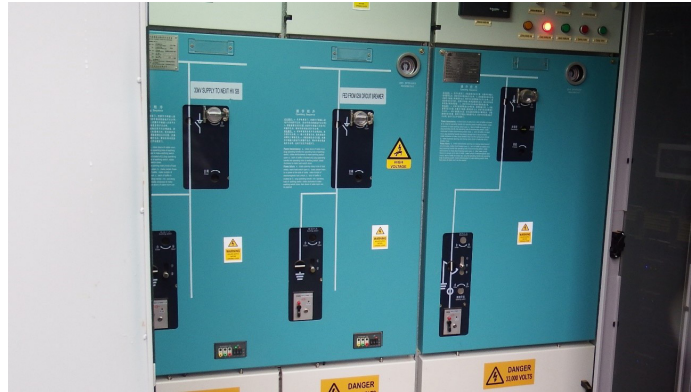
As mentioned above, access to HV substations should be restricted to authorised personnel. Furthermore, the individual switchgear cubicles and switchgear protection devices should be padlocked to further minimize the possibility of an error by an unauthorized person. Over the years, I frequently observed missing locking mechanisms (padlocks) in switchgear cubicles.

Figure 13: Missing locking mechanisms (padlocks) in switchgear cubicles

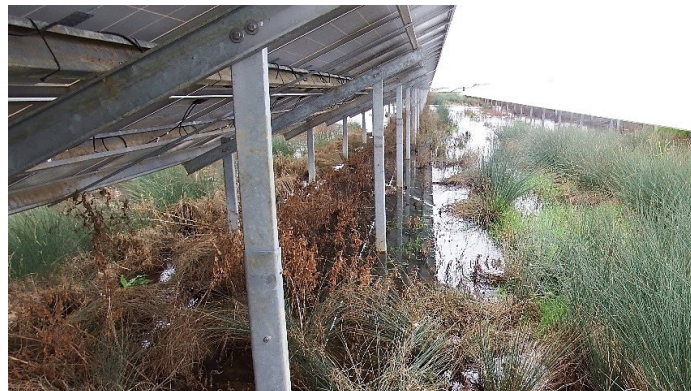
Another issue is the weather. The average annual rainfall in the UK is around 1150 mm. Over the past 30 years it has rained around 156 days a year. Most UK PV plants are built on existing farm fields. Even though there is a requirement for the plants to be reseeded and planted, and for drainage to be implemented, it can take more than five years for hedgerows and grass to grow. This leaves the ground wet and waterlogged after the completion of construction. Even where drainage works have been completed according to design studies, I have often found required drainage levels insufficient such that standing water accumulates on the plant's ground. This can lead to many challenges including access, corrosion and other damage.

Figure 14: Waterlogged area in a PV plant

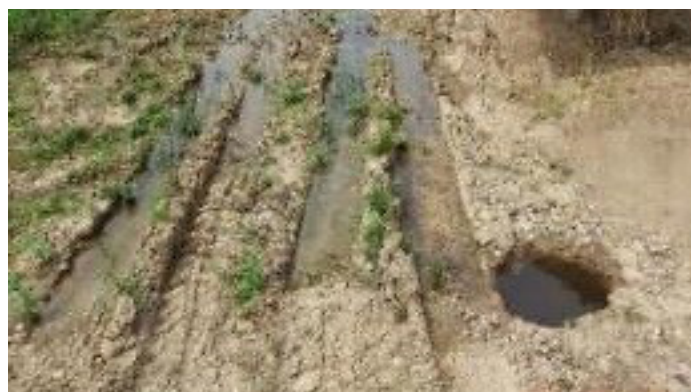
Figure 15: Damaged access tracks

Access tracks can also be affected by bad weather and poor construction, making the entrance to the site challenging for vehicles and personnel. This can affect the response times of an O&M team and potentially represent a hazard. Levelling and compacting works should always be undertaken to restore access tracks, ensuring uninterrupted access to the plant.

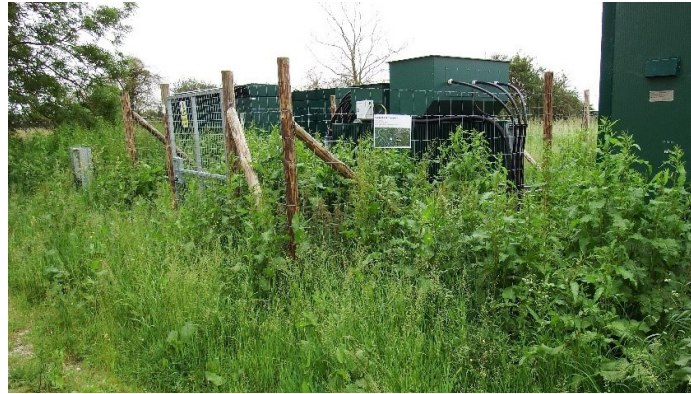
Figure 16: Grown vegetation around a substation

Grown vegetation, weeds and grass present underneath the solar modules can cause problems on a site: Weeds can potentially interfere with electrical connections and cabling while grown vegetation can cast shadows on modules. Vegetation management should be carried out as frequently as needed to ensure that the O&M teams can perform their tasks uninterrupted.
